Manhole Inspection Summary

Manhole # S43CC_098MH

Record Plat: **43CC** Node: **098** Status: **New Manhole (Not in GIS)** Insp Date: **1/8/08 12:00 AM**

Location Address: **btwn rutland av & mcdonogh st** Cross Street: **e.eager st**

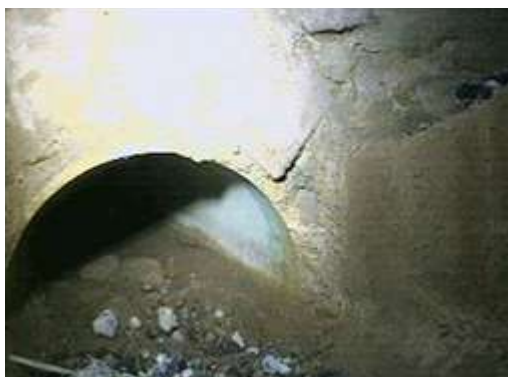
Misc.

channel debris

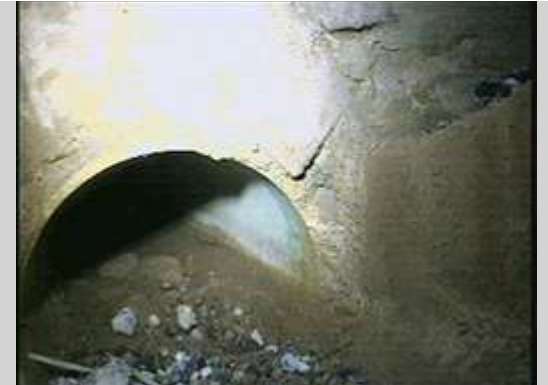
12 O'Clock Outflow

8 in. Circular Gravity Sewer
Pipe Out @ 12 O'Clock

Deposits: ☐ None ☐ Mud ☐ Sludge ☒ Debris ☐ Grease

Silt Depth: 3 (in.) Deposits Extent: Medium
